Title: Wind and impact resistance product testing of a sample of Petrarch Rainscreen Cladding and TEN66 Framing System for CEP Cladding Limited

Report No: N950-12-16605

Client: CEP Cladding Limited, Wainwright Close, Churchfields, Hastings East Sussex TN38 9PP

Issue date: 18 October 2012

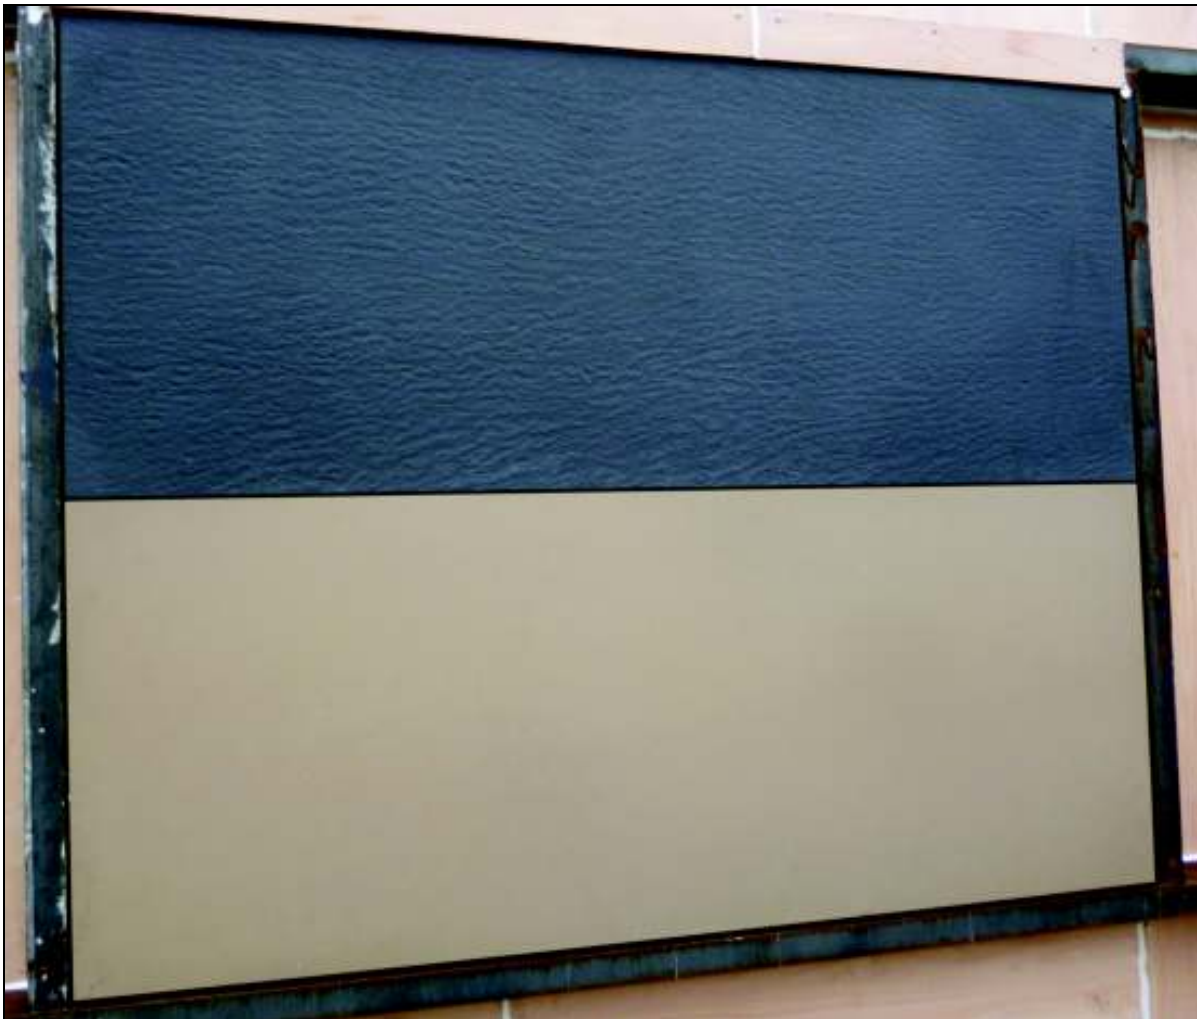
PHOTO 1020975

TEST SAMPLE ELEVATION

The two rainscreen panels measured 3042 mm wide by 1213 mm high each.

The lower panel was 10 mm thick Petrarch fitted with TEN66 mechanical secret fix brackets.

The upper panel was a 7 mm thick Petrarch panel fitted with TEN66 Maxx (factory bonded) secret fix brackets..

An aluminium flat strip was Sika fixed in the horizontal gap between the panels.

The sample was as shown in the photo below and the drawings included as an appendix to this report.

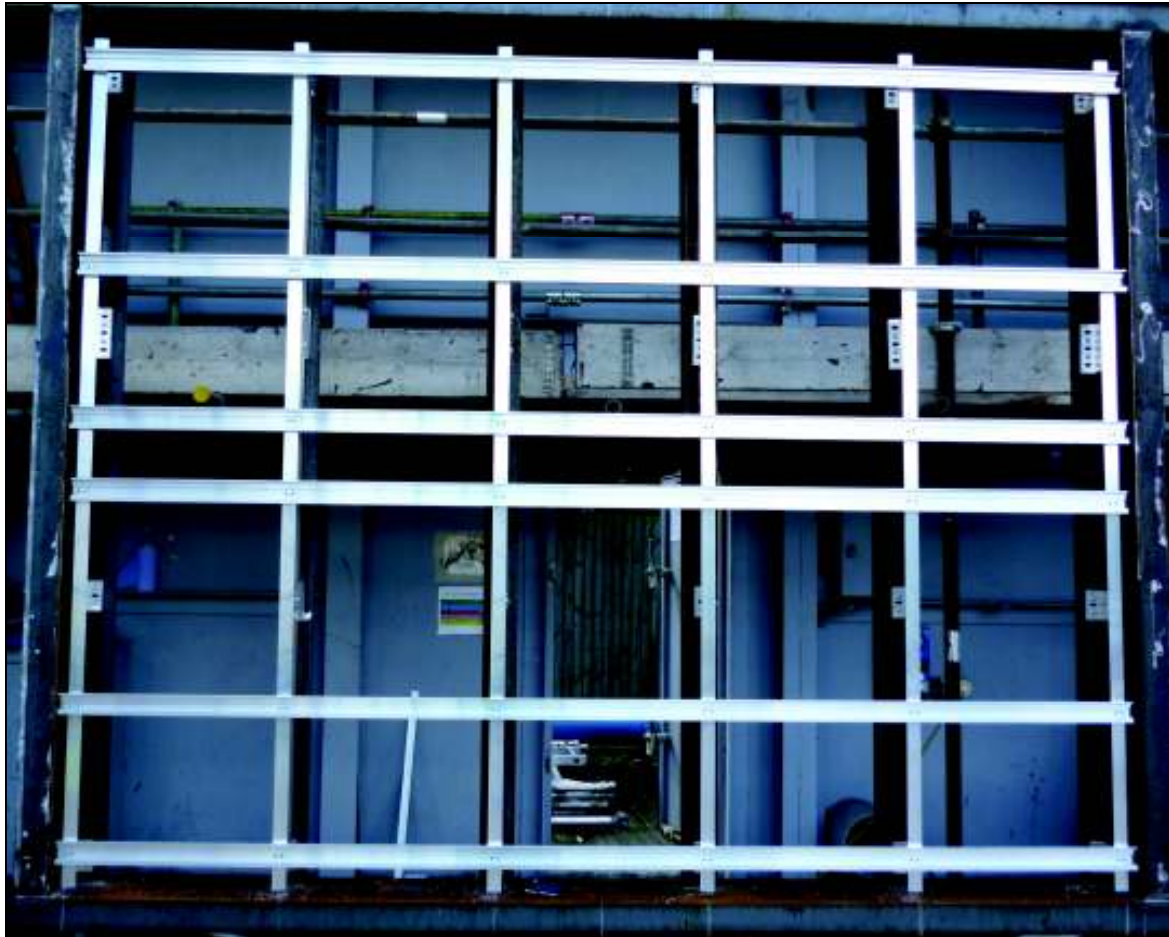
PHOTO 1020961

TEST SAMPLE SUPPORT FRAMEWORK

The TEN66 vertical aluminium support angles were secured to 100 x 100 vertical steel angles via four No.TEN66 fixing brackets per angle. Six No.TEN66 horizontal rails were fixed to the angles. The steel angles and steel channel surround were part of the test rig.

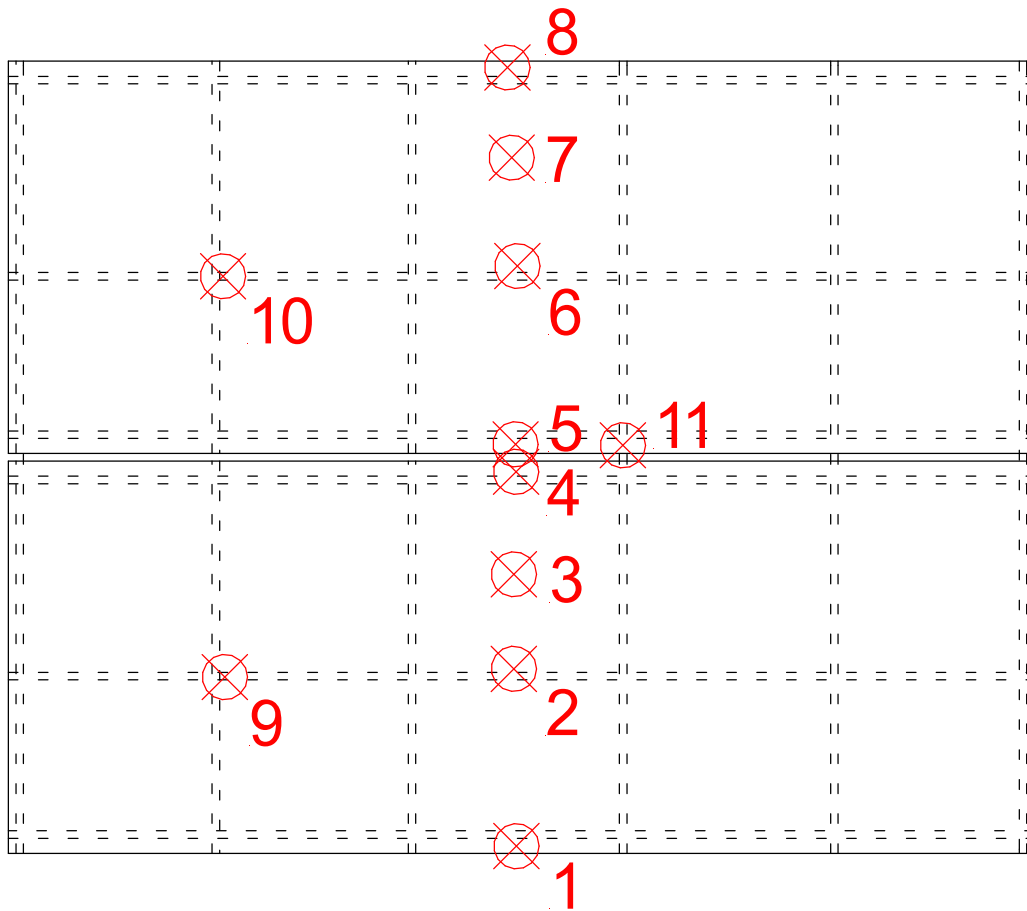
FIGURE 2

DEFLECTION GAUGE LOCATIONS

Internal View

Deflection gauges 1 to 8 on back of panels.

Deflection gauges 9 to 10 on back of rail next to support.

Deflection gauge 11 on back of steel vertical support angle.

Displacement transducers were used to measure the deflection of principle framing members to an accuracy of 0.1 mm. The gauges were set normal to the sample framework at mid-span and as near to the supports of the members as possible and installed in such a way that the measurements were not influenced by the application of pressure or other loading to the sample. The gauges were located at the positions shown in Figure 2.

The deflections measured during the wind resistance test, at the positions shown in Figure 2, are shown in Tables 4 and 5.

The deflections measured during the first and last set of pressure pulses, at the positions shown in Figure 2, are shown in Tables 6 and 7.

The deflections measured during the structural safety test, at the positions shown in Figure 2, are shown in Table 8.

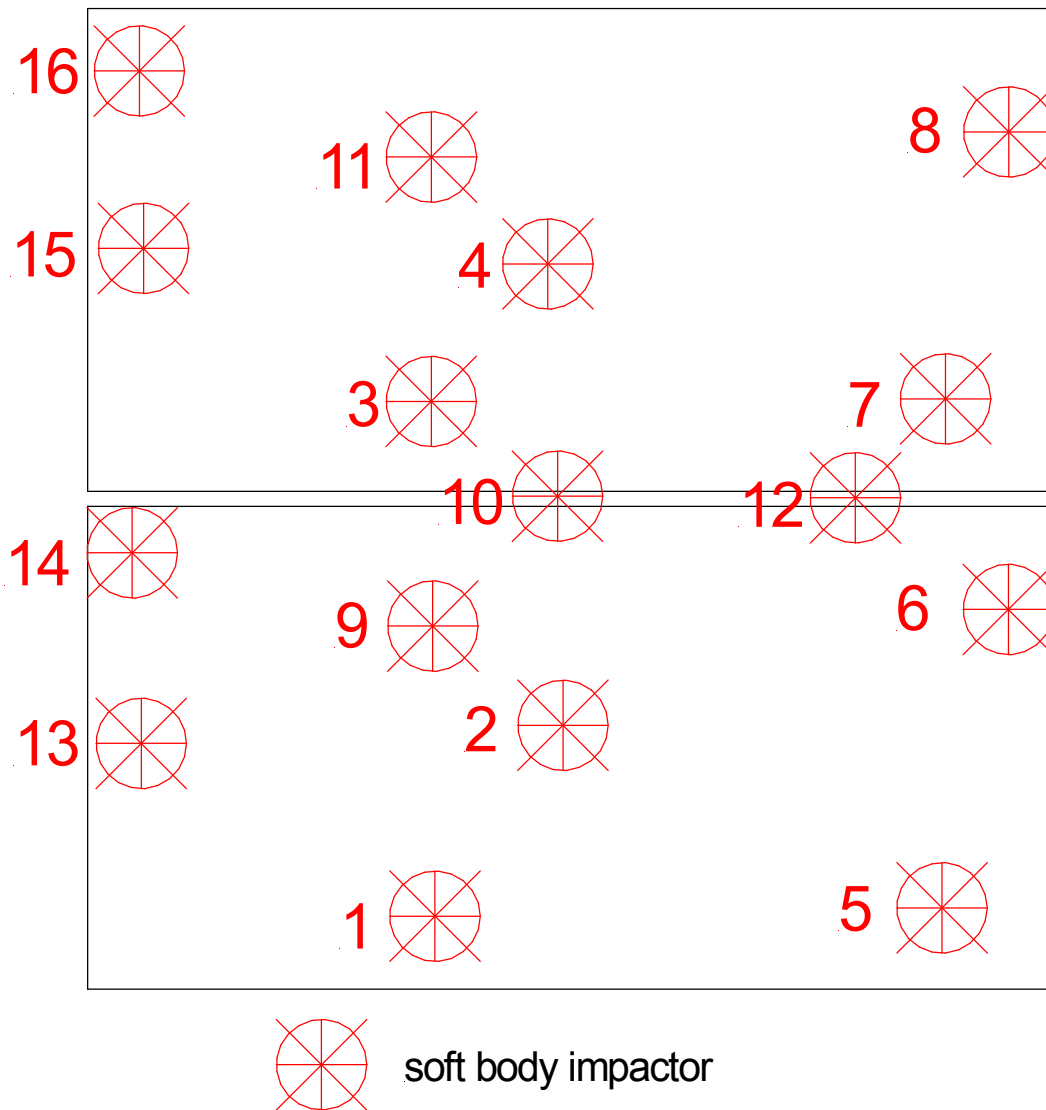
FIGURE 3

SOFT BODY IMPACT TEST LOCATIONS

External View

The impactor almost touched the face of the sample when at rest. It was swung in a pendular movement to hit the sample normal to its face. The test was performed at the locations shown in Figure 3. The impact energies were 120 and 500 Nm at locations 1 to 4 and 500 Nm at all the other locations.

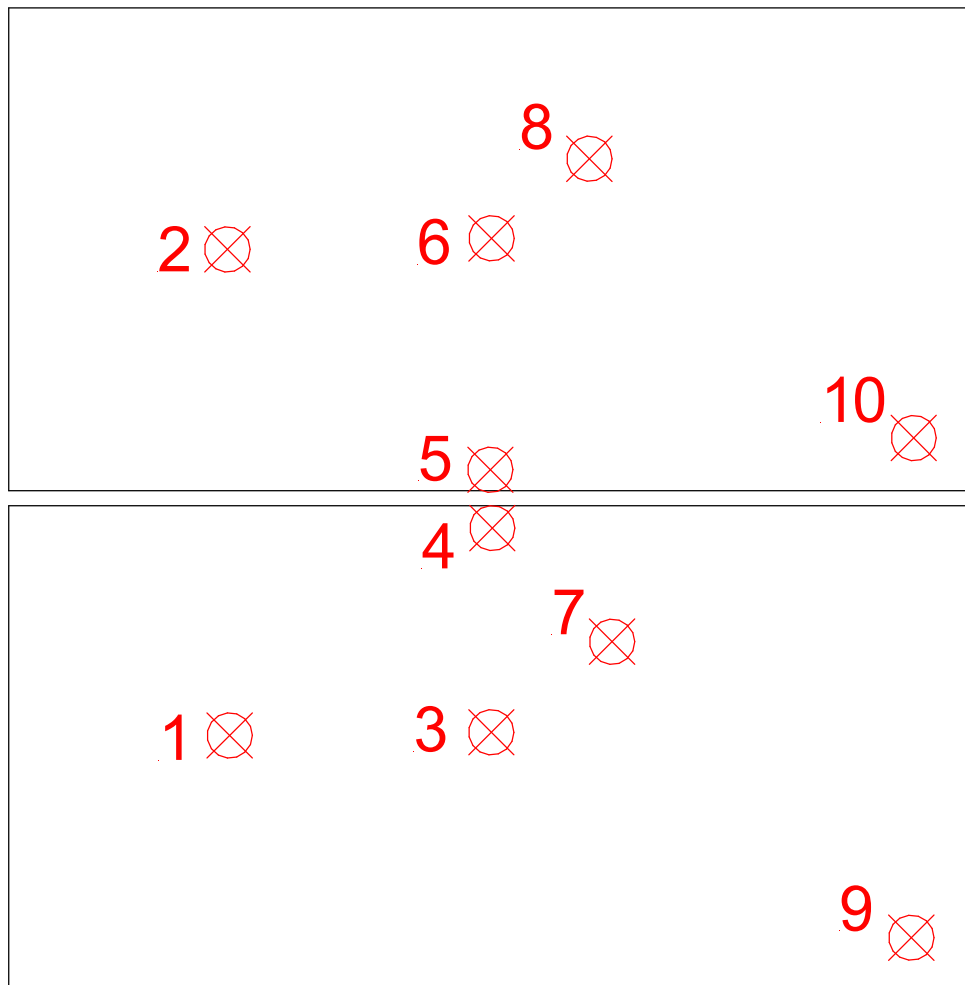
FIGURE 4

HARD BODY IMPACT TEST LOCATIONS

External View

The impactor almost touched the face of the sample when at rest. It was swung in a pendular movement to hit the sample normal to its face. The test was performed at the locations shown in Figure 4. The impact energy was 10 Nm.

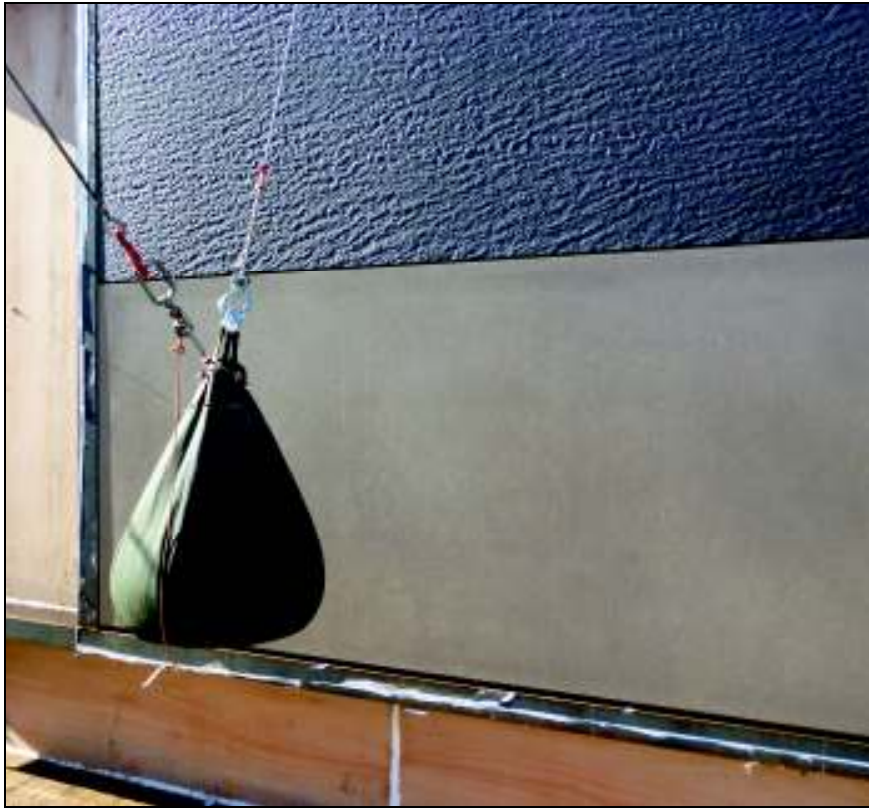
PHOTO 1030028

SOFT BODY IMPACTOR READY FOR RELEASE

The soft body impactor comprised a canvas spherical/conical bag 400 mm in diameter filled with 3 mm diameter glass spheres with a total mass of approximately 50 kg suspended from a cord at least 3 m long.

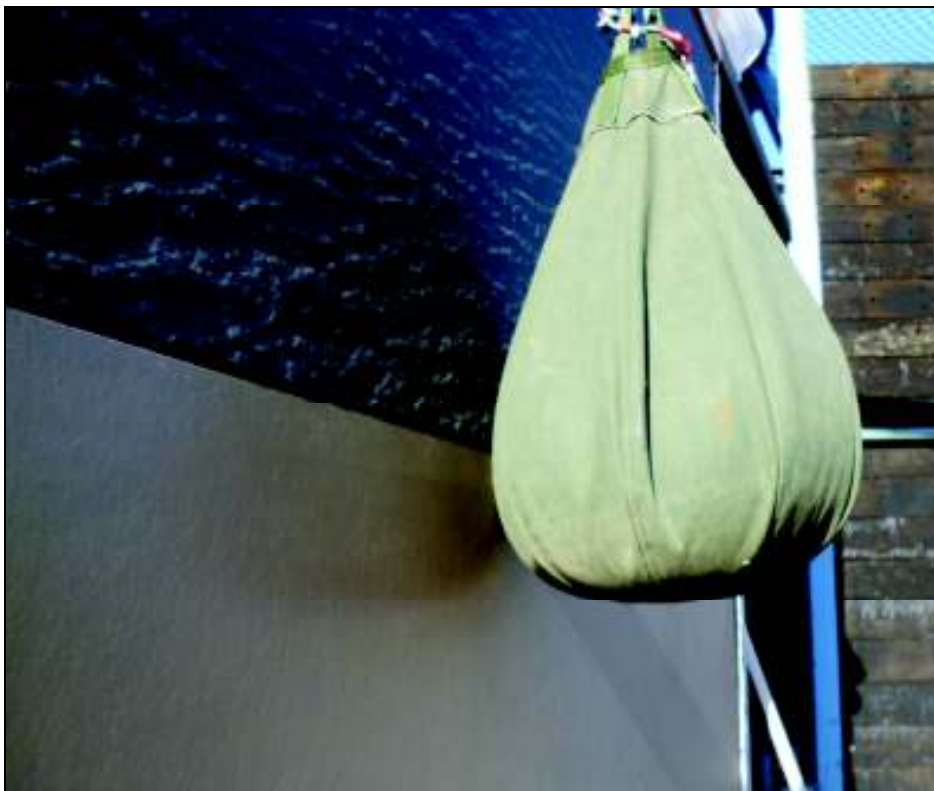
PHOTO 1030035

SOFT BODY IMPACTOR ON PANEL JOINT

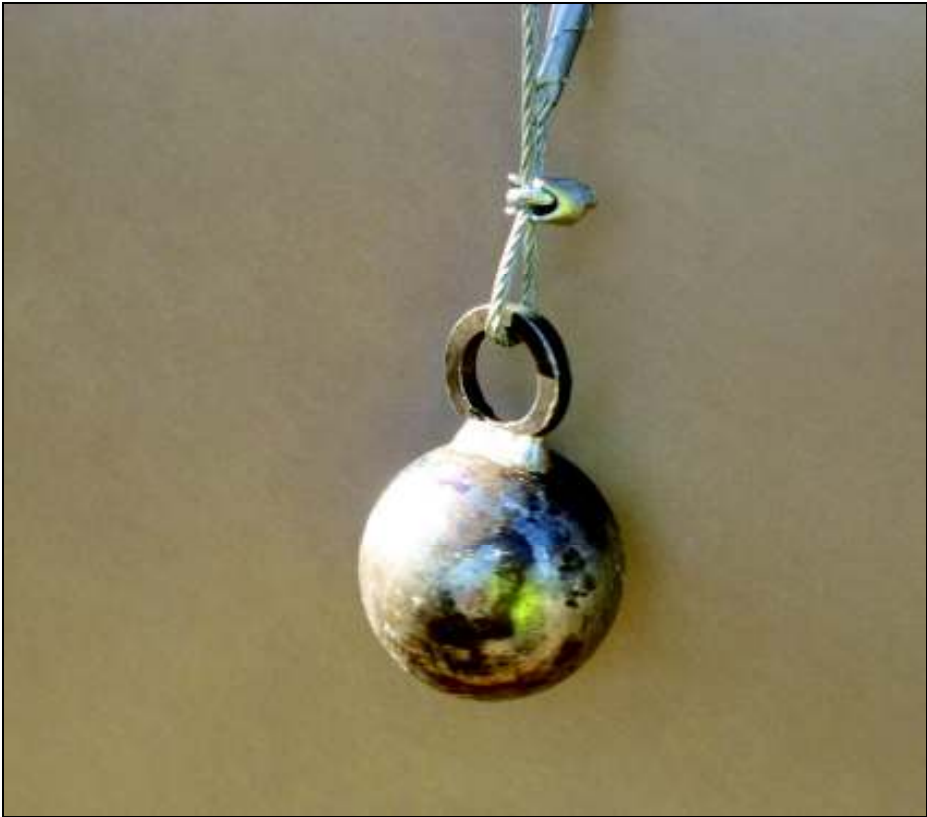
PHOTO 1030035

HARD BODY IMPACTOR ON LOWER PANEL

The hard body impactor was a solid steel ball of 62.5 mm diameter and approximate mass of 1.0 kg.

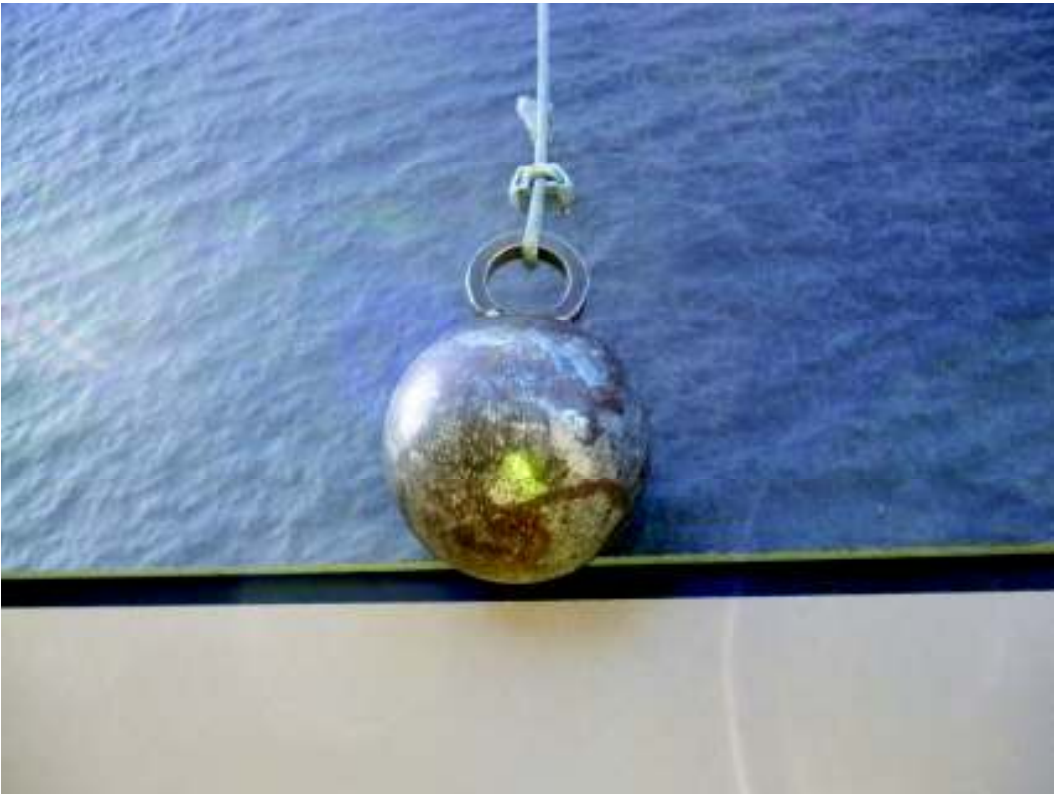
PHOTO 1030039

HARD BODY IMPACTOR ON UPPER PANEL
